PUBLIC ENVIRONMENT REPORT GUIDELINES

Kingston Pier Channel Construction Project, Norfolk Island (EPBC 2021/9124)

GUIDELINES FOR A DRAFT PUBLIC ENVIRONMENT REPORT

The following guidelines have been prepared for the Kingston Pier Channel Construction Project, Norfolk Island (project), which will be undertaken by the Department of Infrastructure, Transport, Regional Development and Communications (proponent).

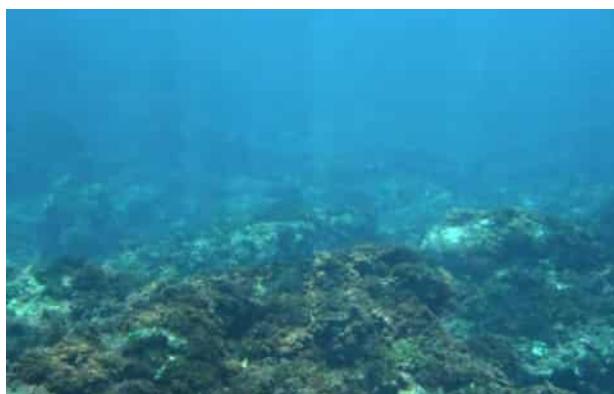
Figure 77: Rock reef with fissures developing as water depth increases. (Image taken from 201117_End Kingston Pier survey JB, 02:43).
