Case Details

Site Diagram 87 - H046

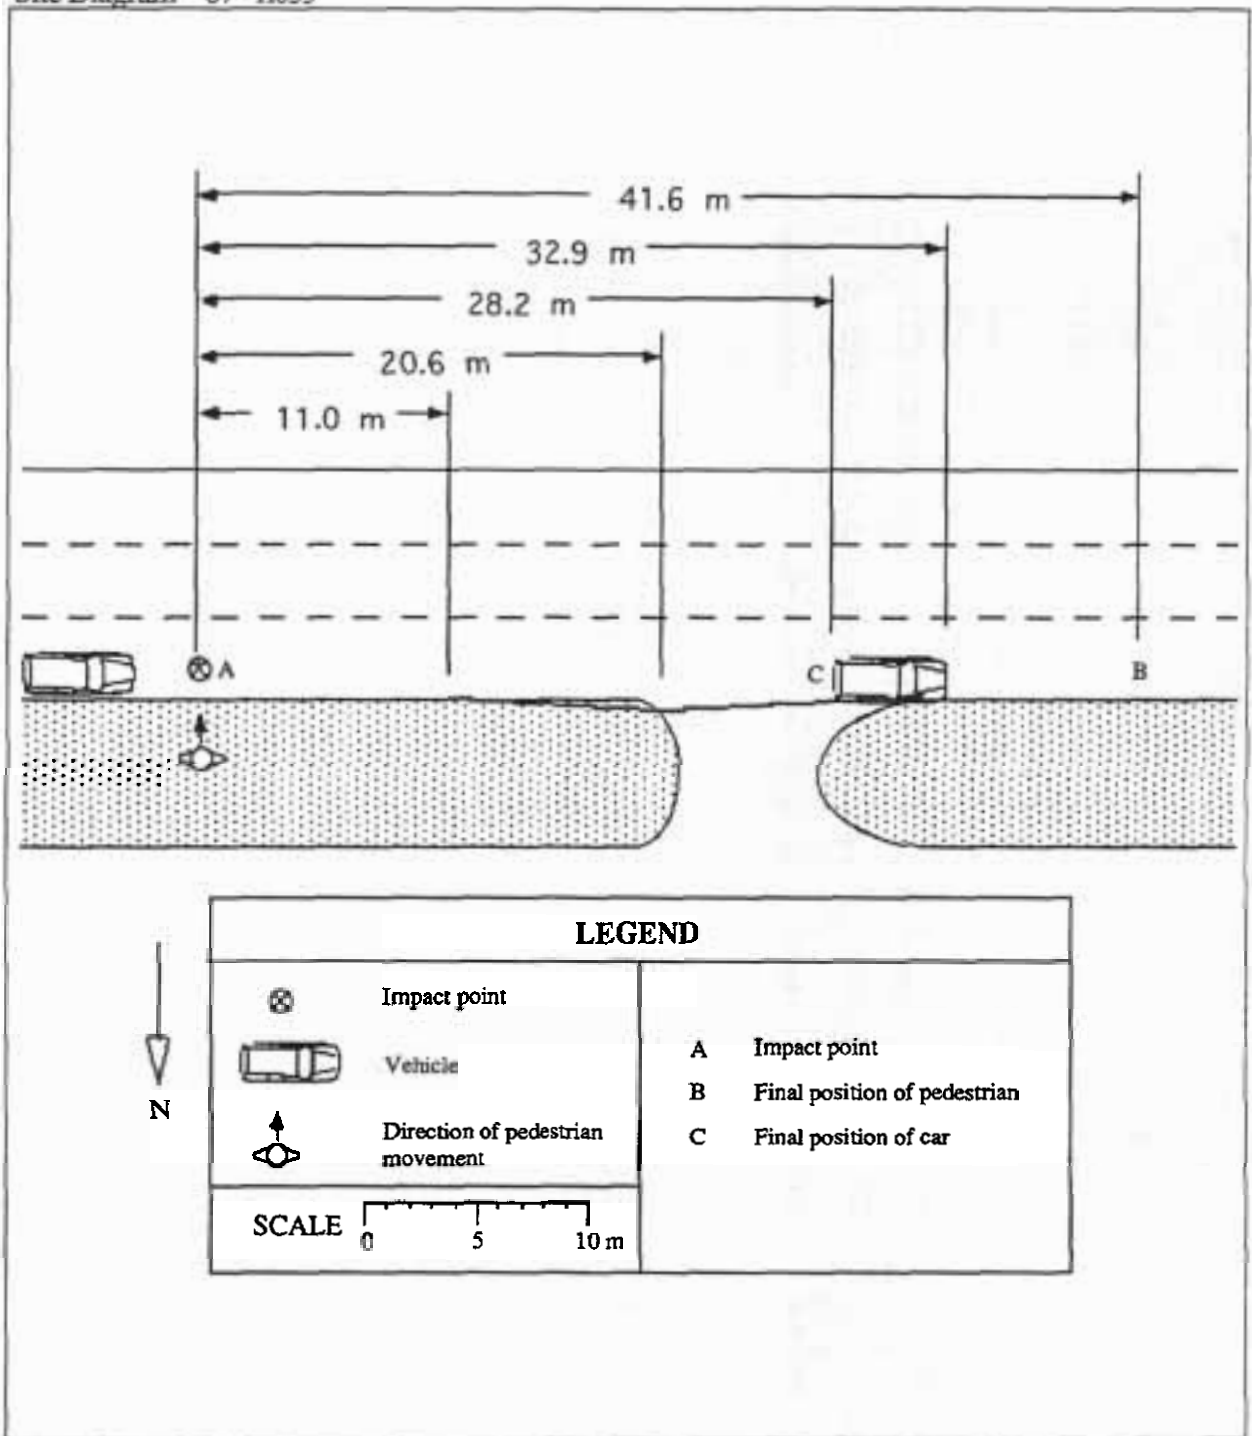
The vehicle was travelling in a westerly direction at about 60 km/hr. The pedestrian was running across the road from north to south and appeared to be trying to beat the traffic. The driver had just passed through an intersection where the lights had just turned green. The speed of the vehicle was verified by a following driver as they did not need to slow for the red light. The driver of vehicle 1 stated that she saw the pedestrian about 1 metre in front of her vehicle and could not remember taking any evasive action. The driver of the following vehicle stated that he saw the brake lights come on as the car swerved onto the median strip after the impact, and then the car return to the road stopping a short distance later. The collision occurred at point A with the pedestrian being struck on his left side. He was hit by the front of the bonnet just right of centre, then rolled up impacting his head on the plenum and was thrown forward coming to rest at point B. The car stopped at point C.

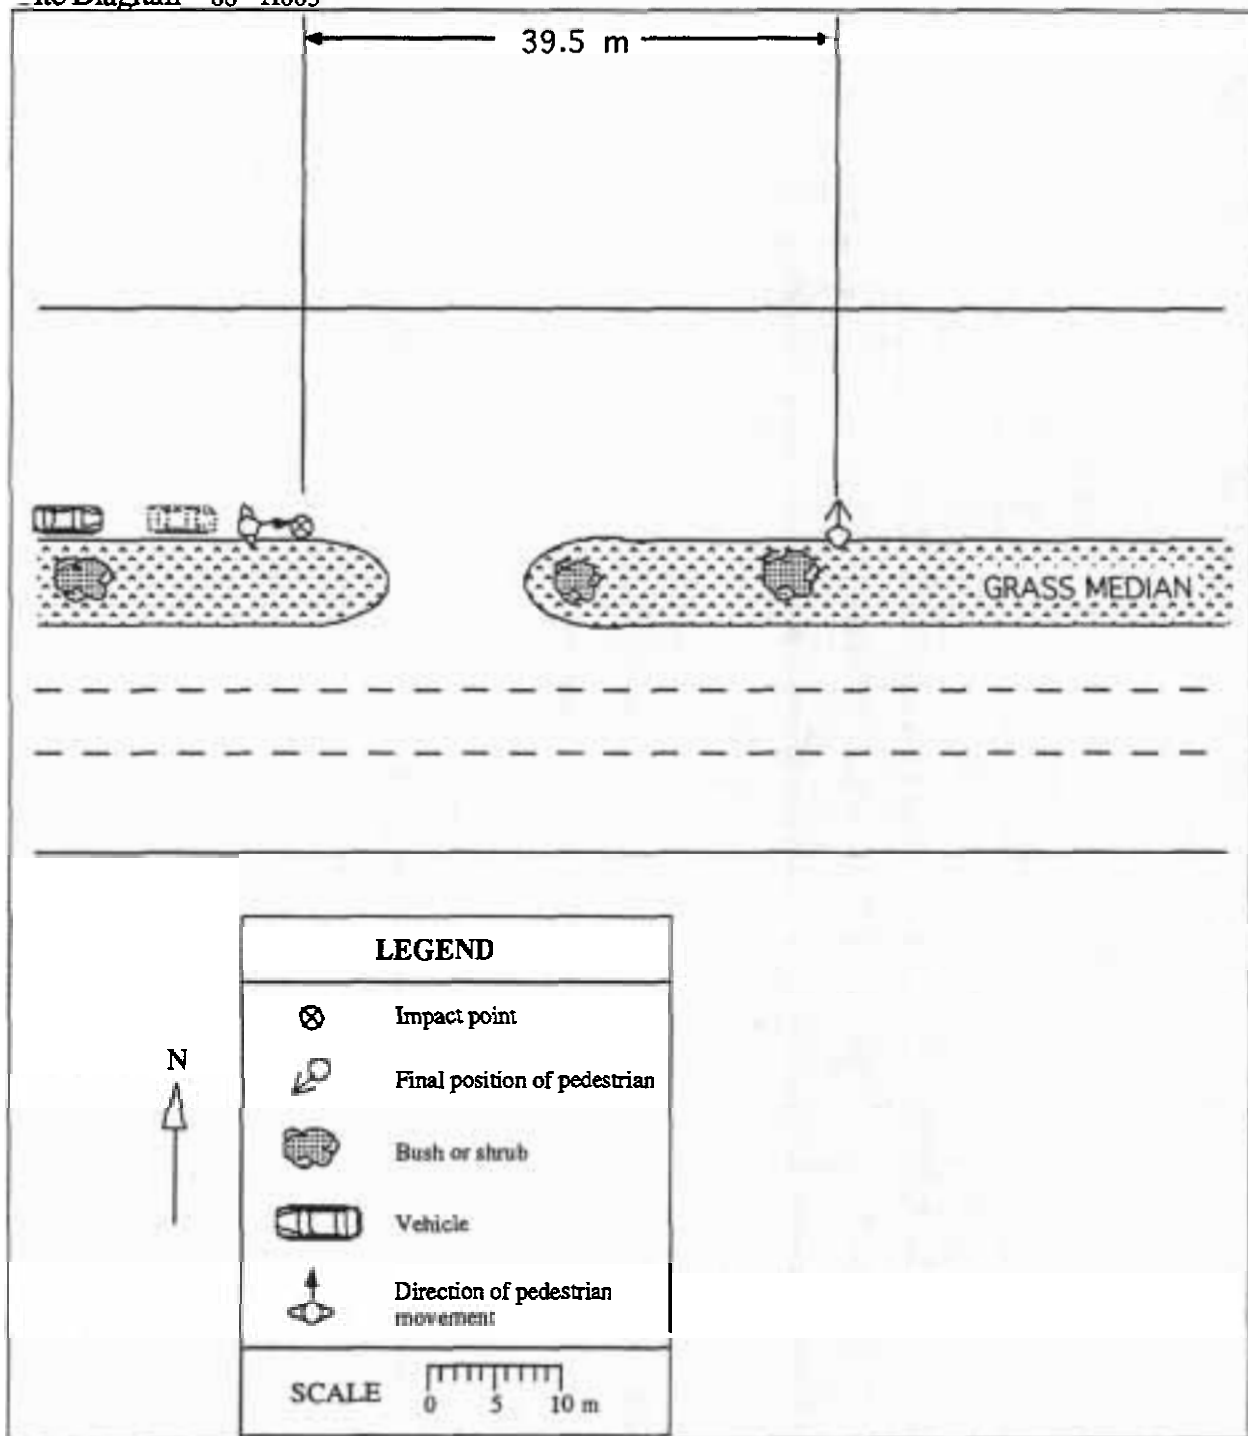
ite Diagram 88 - H003

The car was travelling east and collided with a pedestrian crossing the road diagonally in a northerly direction. The driver stated that he was driving near the median strip at about 60 km/hr when he saw the pedestrian about 5 metres in front of him and about one and a half metres off the median strip walking in a easterly direction. He applied his brakes before colliding with the pedestrian. A witness who was following behind the driver stated that the driver was travelling about 60 km/hr and did not appear to take any evasive action at that time. The pedestrian was hit on her back by the front left of the vehicle. The road was normally a three lane road for east bound traffic but it was not marked with lane lines at the time of the accident.

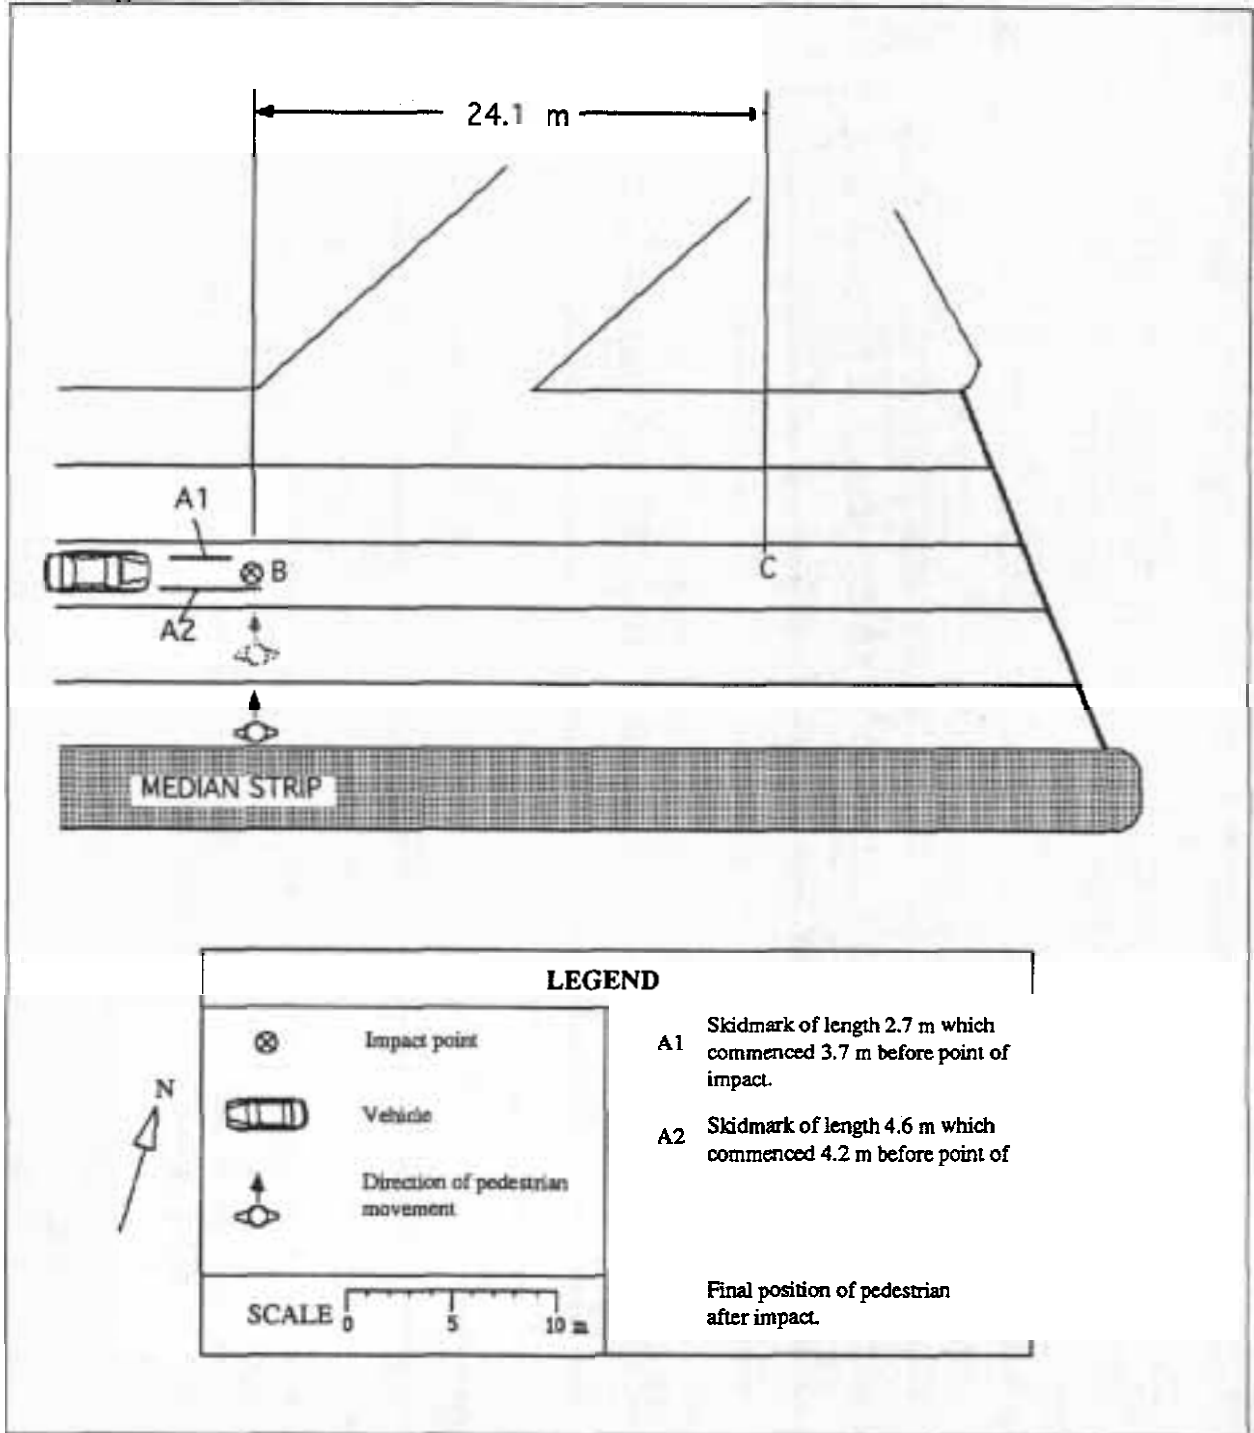
The car was travelling north east and collided with a pedestrian who was crossing the road in a north westerly direction. The driver stated that he was travelling at about 60 km/hr and estimated that he saw the pedestrian about two feet in front of him. The driver braked as soon as he saw the pedestrian, which was before impact as indicated by the impact point (point B) and skid marks (point A1 & A2). The driver then went through the intersection and stopped. The traffic lights at the intersection at the time were green for traffic heading north east . An independent witness supported the driver's estimated of travel speed.

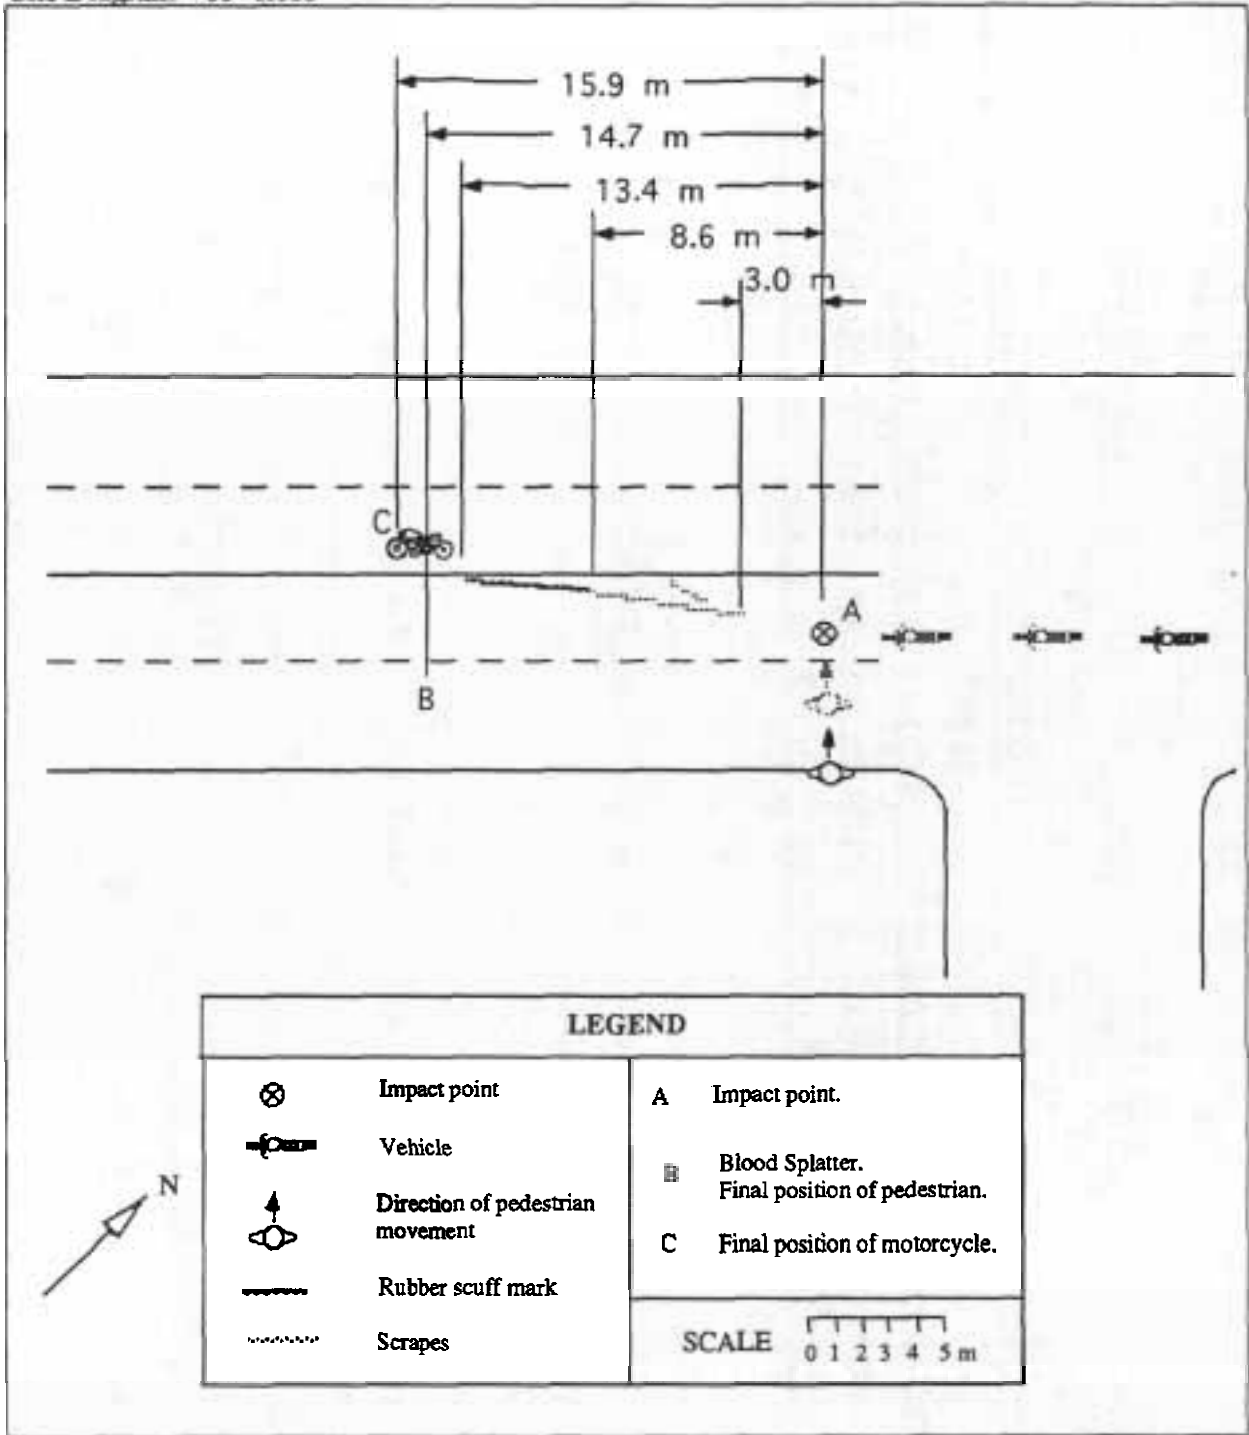
A motorcycle travelling in a south westerly direction collided with a pedestrian who was crossing the road in a north westerly direction. The rider stated that he was travelling at about 62 km/hr in the lane closest to the centre of the road. The rider also stated that he was looking at his rear vision mirror just prior to the impact and when he looked up the pedestrian was in front of him. The rider braked before impact and said that the vehicle slowed down a bit but not much. There was no other witnesses.

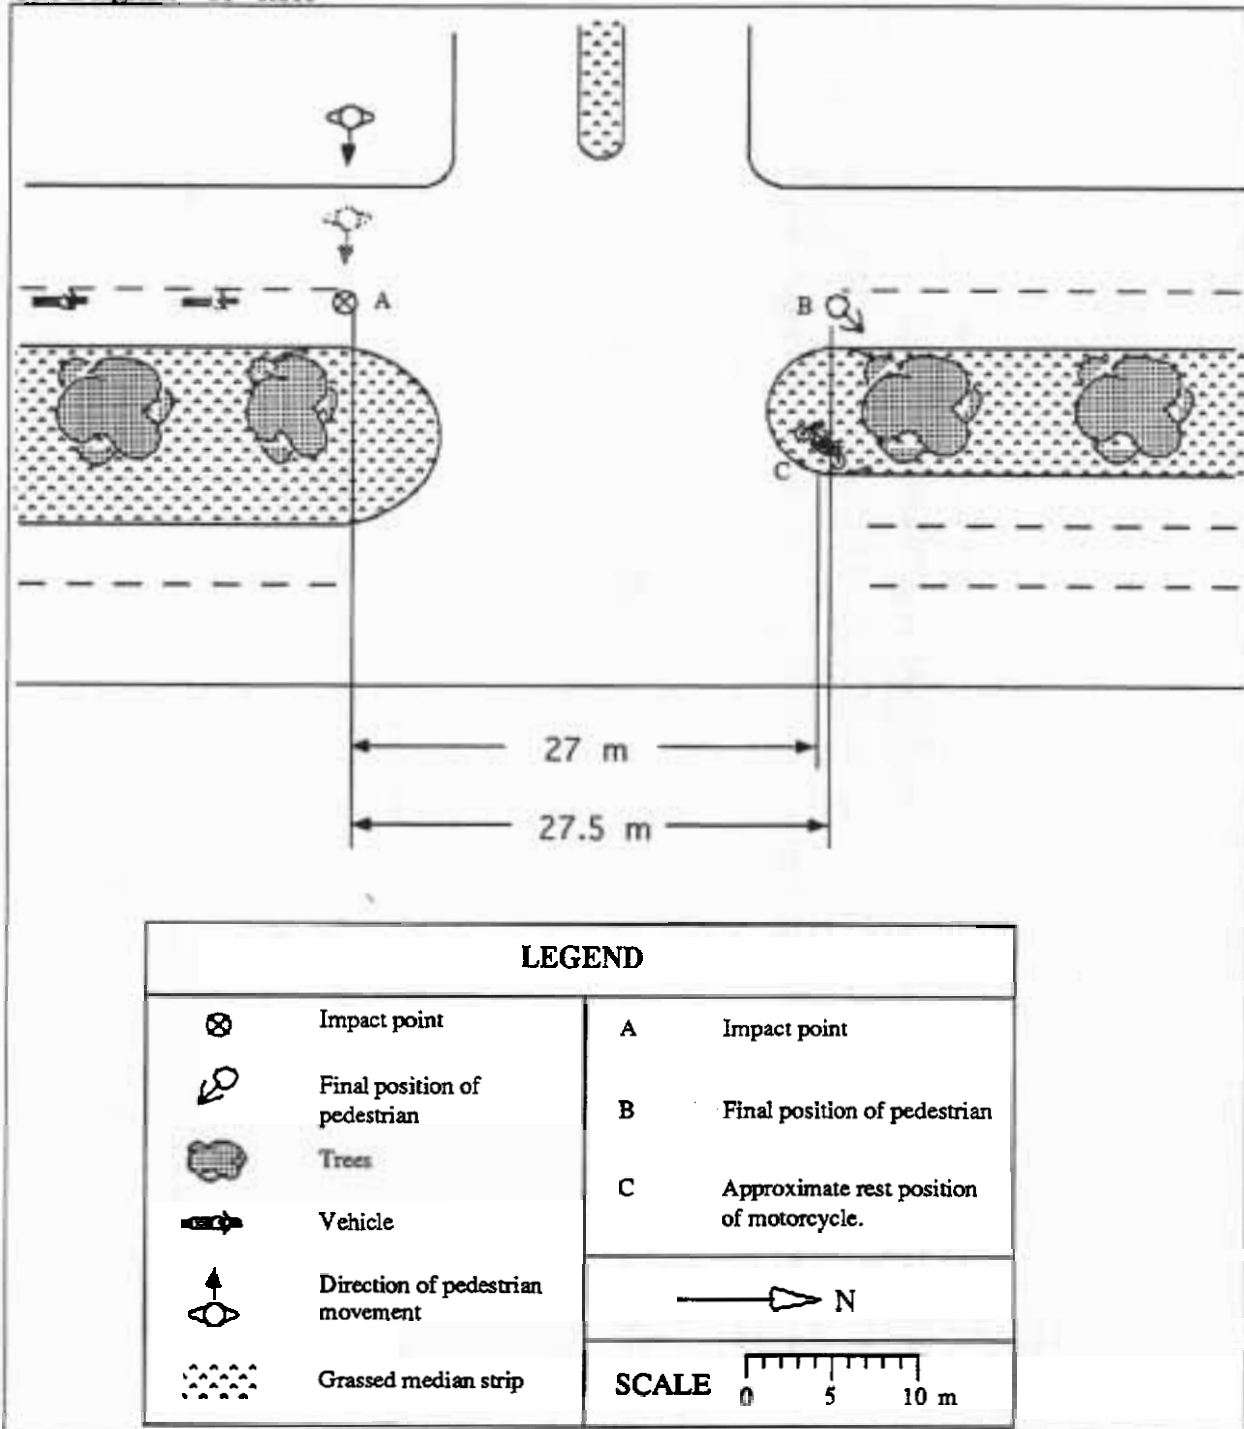
The motorcycle was travelling north in the lane closest to the median strip when it collided with a pedestrian crossing the road from west to east. The rider stated that he was travelling at about 60 km/hr and first saw the pedestrian about 14 metres away near the centre line dividing the two lanes. The rider did not brake or swerve before the impact. An independent witness to the accident estimated the speed of the motorcycle to be 70 to 80 km/hr. The witness was travelling south at that time and was level with the junction of the roads. Another witness, who had been overtaken by the motorcycle, estimated that the vehicle was travelling at 110 to 120 km/hr approximately 370 metres south of the point of impact. After impact, the rider was knocked out of his seat but manage to ride the motorcycle over the median strip and over the kerb, where it was involved with a minor collision with a tree.

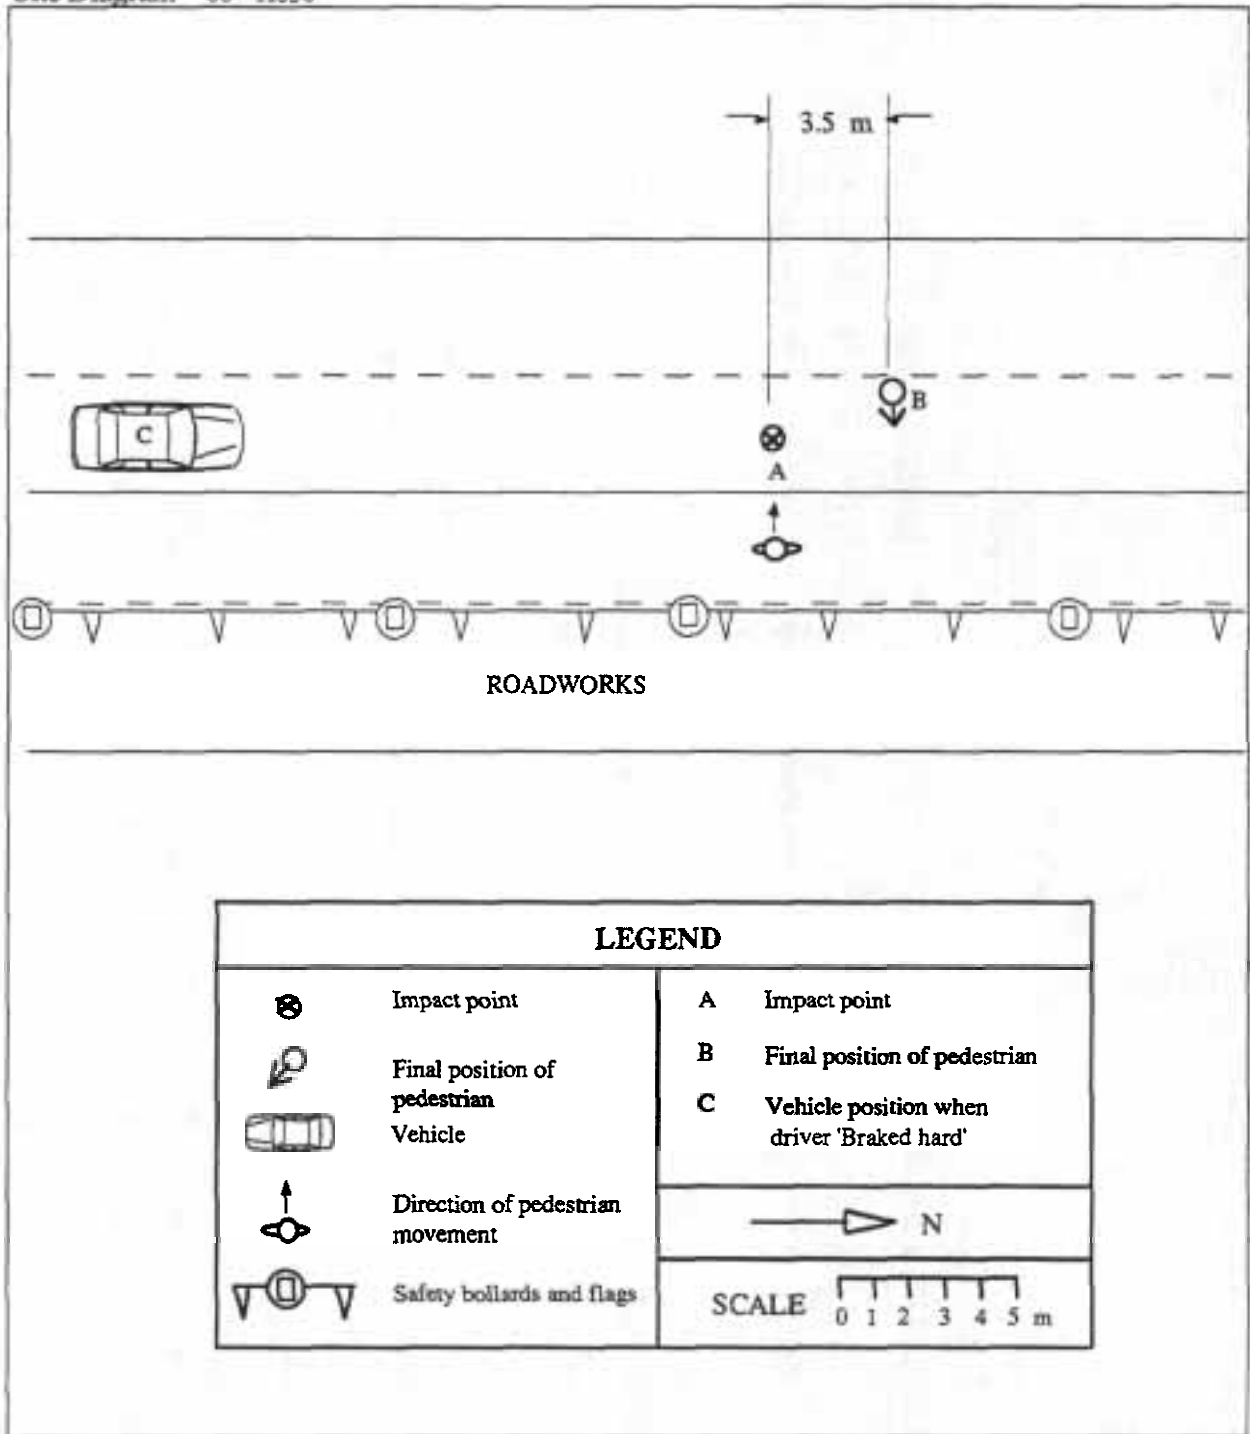
The car was travelling in a northerly direction in the right hand lane. The pedestrian was crossing the road in a westerly direction. The driver saw the pedestrian when he was 30 metres away and slowed to about 50 km/hr, he then saw the pedestrian stop on the lane marking so he continued on but did not accelerate. When the vehicle was 3 car lengths away (at point C), the pedestrian stepped in front of the vehicle, and the driver braked hard. The pedestrian was hit (at point A) on his left hand side by the centre of the car and he then rolled onto the bonnet impacting with the windscreen before rolling forward off the front of the car coming to rest at point B.
